No. 304 (third publication).—The following particulars, etc., relative to the above, issued by the British Admiralty (No. 907 of 1922), are republished :—

The Calcutta Gazette

WEDNESDAY, AUGUST 30, 1922.

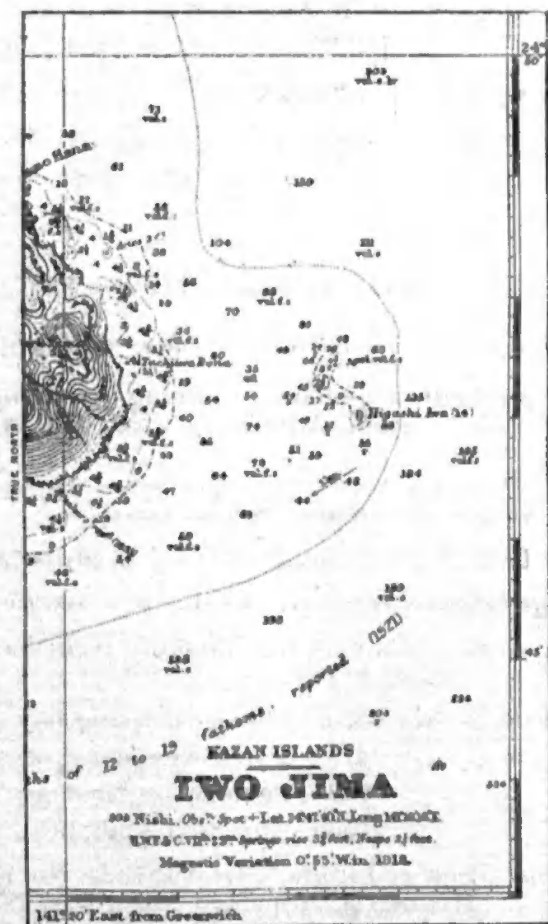
Reproduction of Portion of Chart N° 1100

Note.—It will be observed that the note with regard to rocks and breakers reported between Iwo jima and Higashi iwa has been omitted from the reproduction.
